# POSSE TECHNOTES

Volume 1, No. 1 / Summer 1999

## NAVSEA Supports Salvage of M/V Concorde Spirit

## USS RADFORD Collision Initial Damage Assessment and Drydocking Evaluation

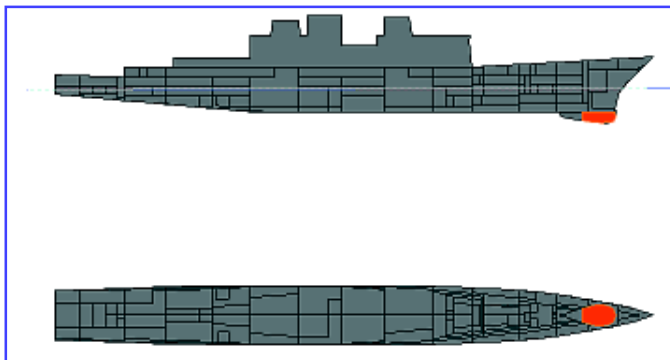
Initial condition with sonar dome "flooded"

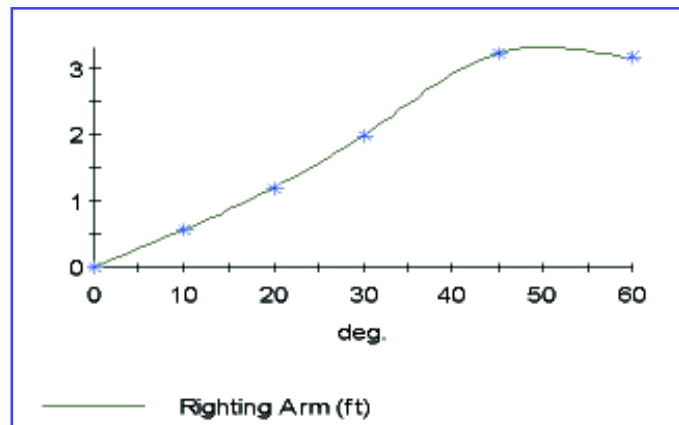
Initial damaged condition with free-flooding of the damaged compartments

elements' effectiveness was reduced by applying a "corrosion" factor, reducing the contribution of the elements to the section moduli and shear area calculations. The damaged section (e.g. at frame 69) was calculated to have lost up to 60% of it's original section moduli (to both keel and deck) and approximately 35% of it's shear area about it's horizontal neutral axis (i.e. for vertical bending and shear).

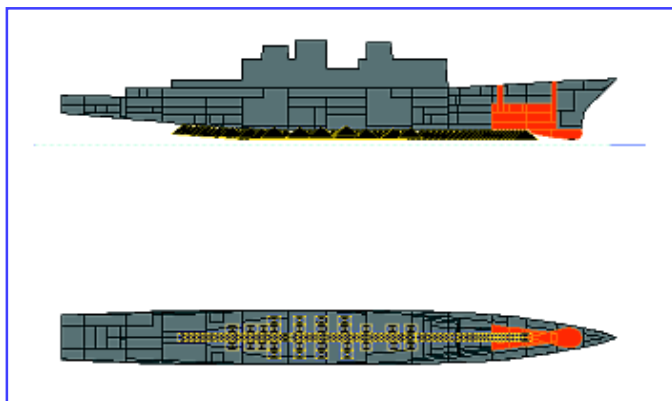
The drydock block buildup was modeled by 88 individual "grounding points", at specified locations of the individual drydock blocks. POSSE rigorously calculated reaction force on each of the individual blocks required to satisfy force equilibrium. For the initial case where the drydock is pumped down, but the sonar dome remains full, individual block loads (in Ltons) were calculated to range from 194 ltons (on the aft keel block) to 21 ltons (on the forward keel block). It should be noted that this approach assumes that the ship is represented by a rigid body, with the given shape, weight and center of gravity. Thus, the block loading distribution is calculated based upon the ship's geometry (offsets), center of gravity, and block distribution (locations). The hull was assumed NOT to deflect due to the drydocking (i.e. "hull deflection" was set to the default "no deflection of hull girder"

Drydock blocking modeled using POSSE's "Multiple Point Grounding" capability

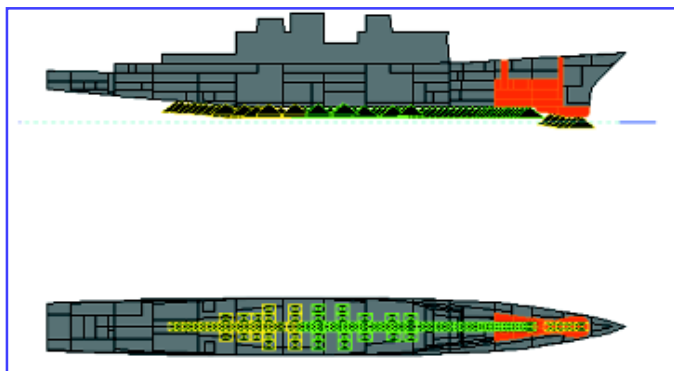
Drydock blocking modeled, with sonar dome blocking added

achieve much effect on reducing bending moments and stresses, the blocking under the sonar dome would need to have sufficient height to ensure they are sufficiently loaded to reduce bending moments across the damaged section. For example, where blocks under the sonar dome are set  $\frac{1}{2}$ " above the height contour of the sonar dome, bending stresses across the damaged section could be reduced to 18 ksi at the keel (compression) and 11 ksi at the strength deck (tension), providing an acceptable factor of safety to yield.

- (1) Dewater the sonar dome prior to emptying the drydock or dewatering the sonar dome during the drydock dewatering process, but prior to the drydock becoming empty. This provides reduced bending moments at the damaged section. Bending stress at the damage section with the sonar dome dewatered were calculated to be reduced to approximately 33 ksi at the keel (compression) and 19 ksi at the strength deck (tension).
- (2) Add drydock blocking under the sonar dome foundation (bellyband), thus reducing bending moments across the damaged section. In order for this to

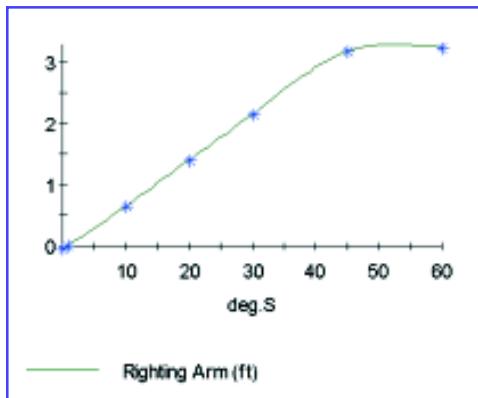
DD968 Stern Section Righting Arm Curve

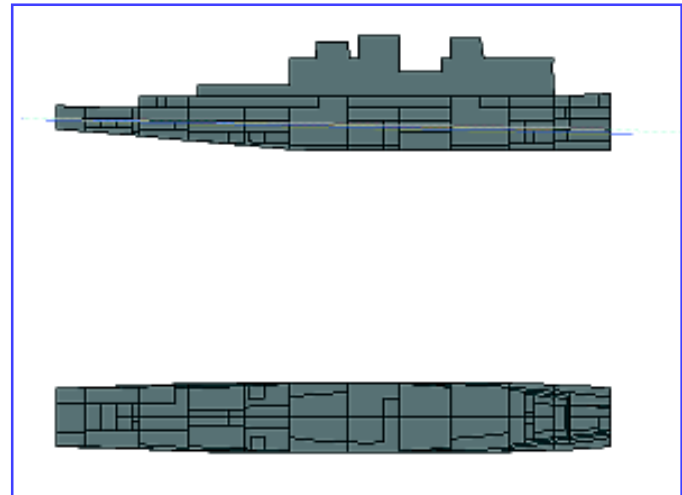
DD968 Stern Section Afloat Condition
